PHASE I ENVIRONMENTAL SITE ASSESSMENT REPORT

R&C and C&R Realty Trust Property Former Bird Property Marshall and Prentice Streets Holliston, Massachusetts

May 2, 2005

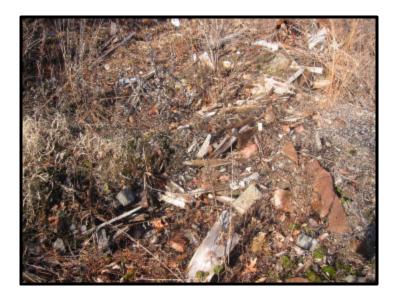
Pile of Empty Automobile Gasoline Tanks to the South of the Disposal Area General Debris in Debris Field to the West of Marshall Street

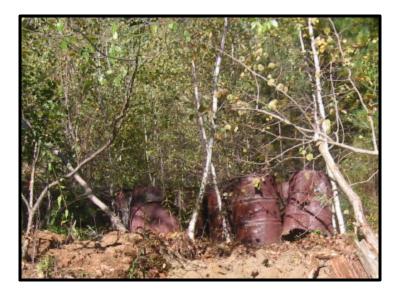
Drums in the Eastern Pond Area to the Northeast of the Pond

Approximately a dozen empty steel drums were observed to the north of the access road, about 100 feet to the northeast of the pond. These drums appear to have been placed at this location during prior removal actions. Coler & Colantonio, Inc. concludes that soil samples be collected from this area, and analyzed for a minimum petroleum and PCB type parameters.
